**Subject: Revised Draft Trip Report for the Riverside Avenue Site
Riverside Avenue, Newark, Essex County, New Jersey
EPA Contract No. EP-S7-06-01
TDD No. 0178
Document Tracking No. 1039**

**REVISED DRAFT TRIP REPORT
RIVERSIDE AVENUE SITE
NEWARK, NJ**

Technical Direction Document No. 0178
Document Tracking No. 1039

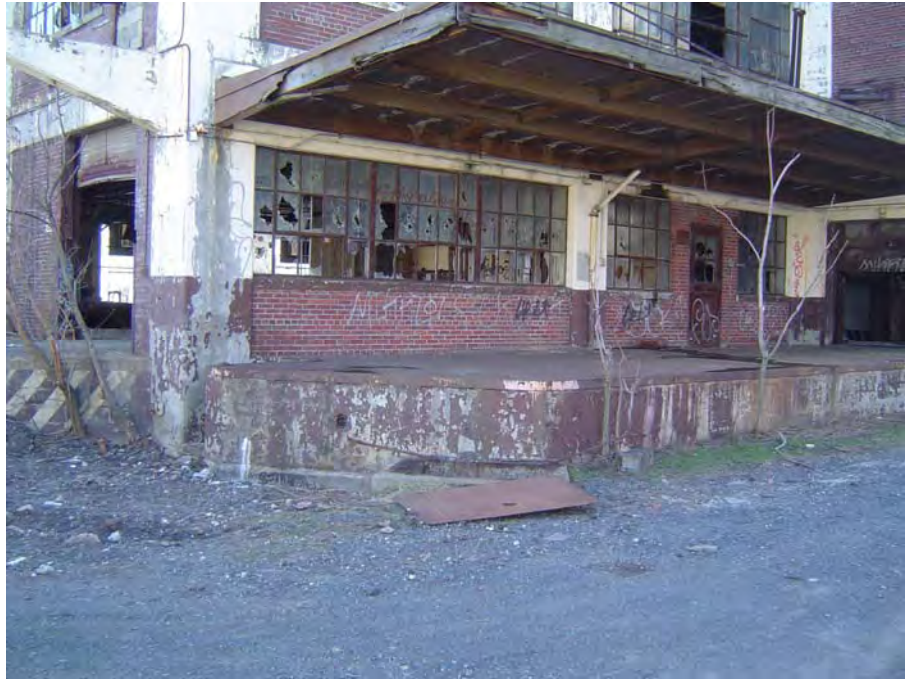
Description: View of loading dock and northwest corner of Building #7.

Photo orientation: Facing south

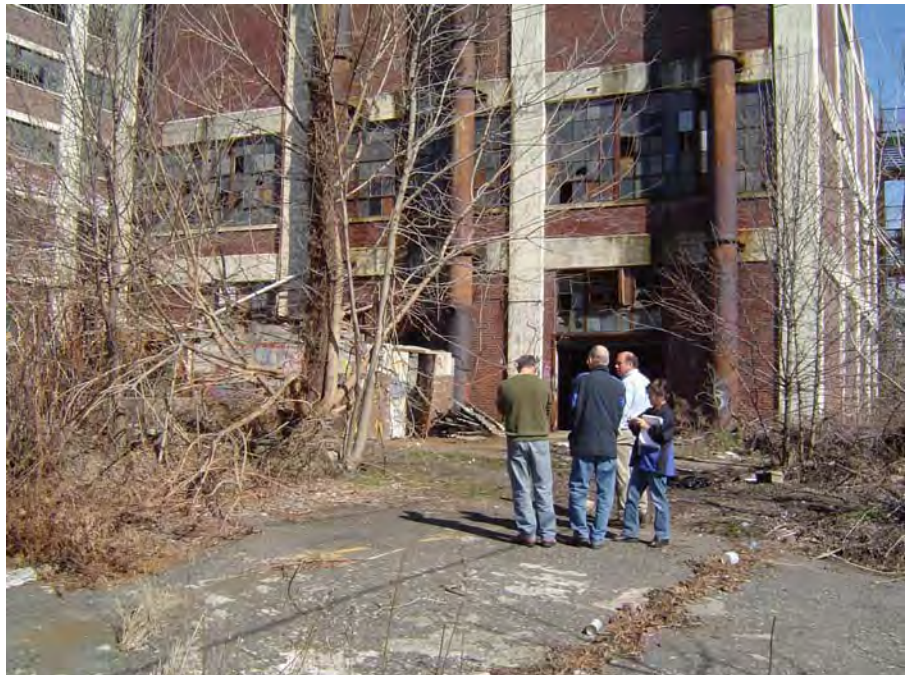
Photograph No. 2

Description: View of southern side of Building #7.

Photo orientation: Facing north

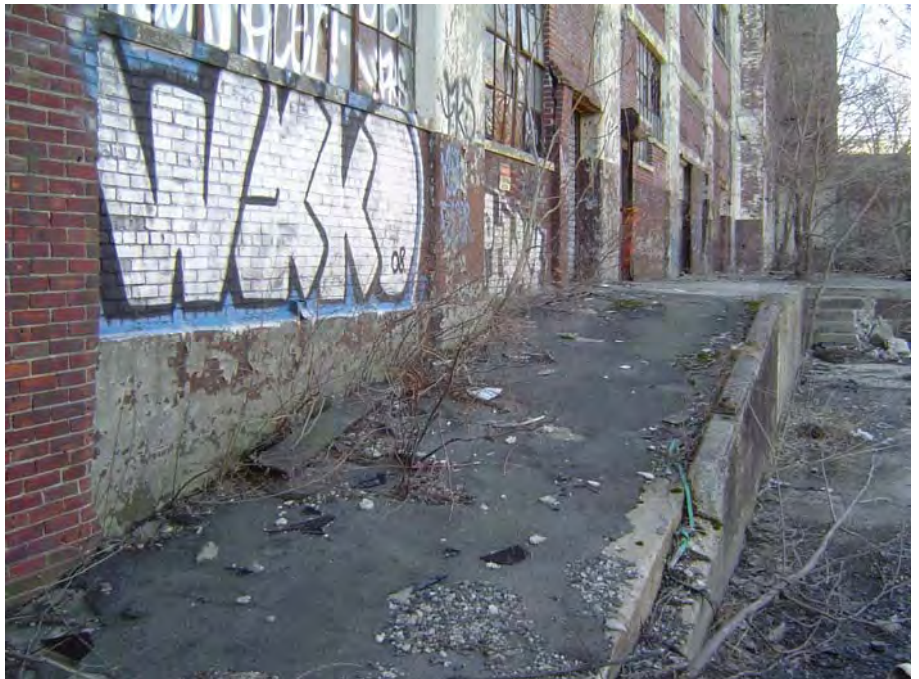
**Description: View of
ramp/loading dock area of
Building #12.**

Photo orientation: Facing east.

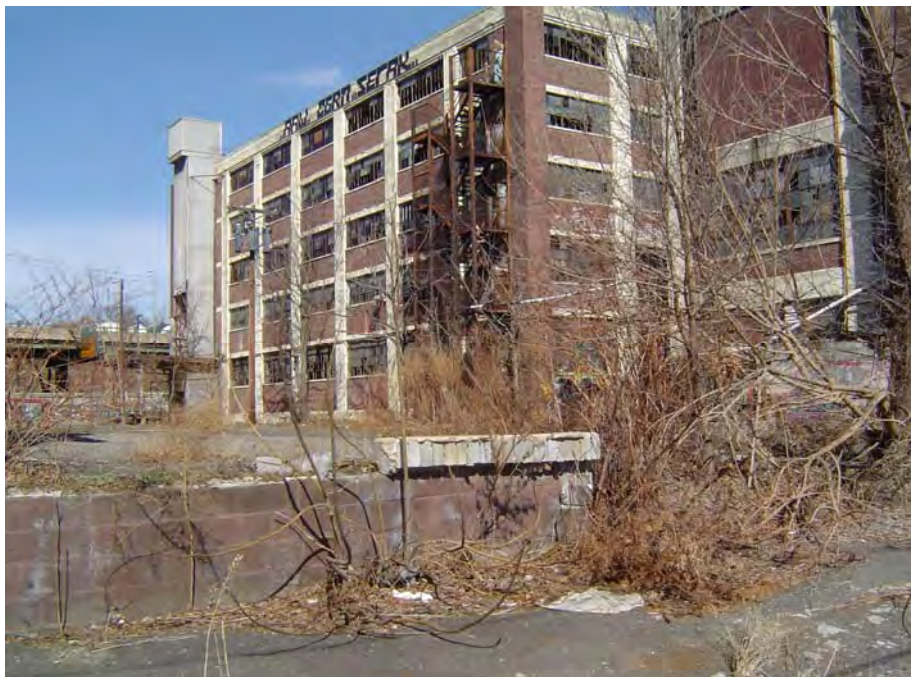
Photograph No. 4

**Description: View of southern
side of Building 12.**

**Photo orientation: Facing
northwest.**

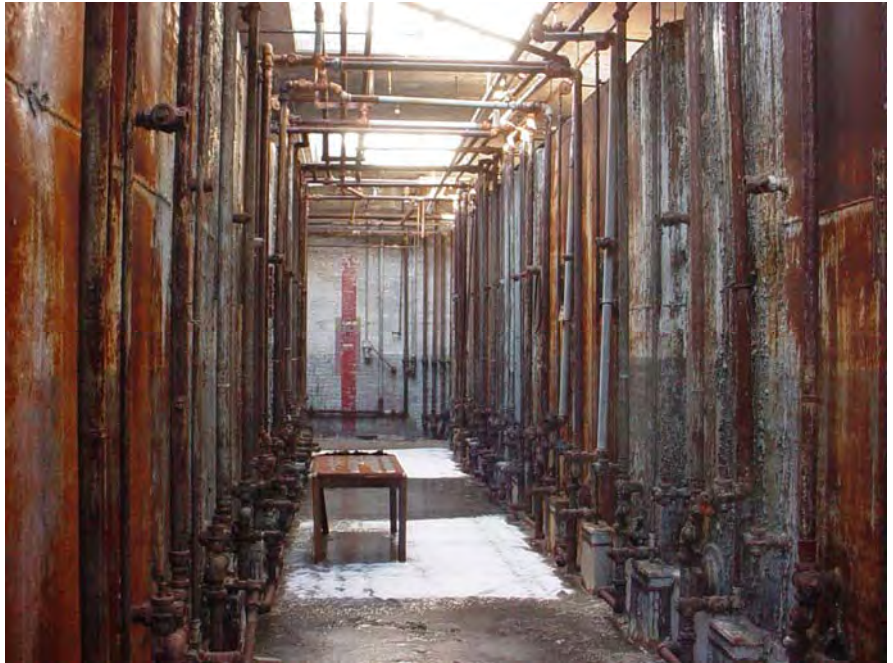
Description: View of former paint and varnish tanks on third floor of Building #7 (north room).

Photo orientation: Facing east southeast.

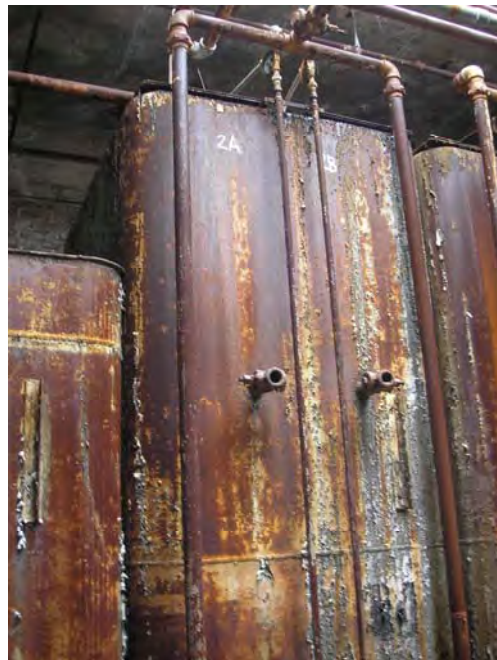
Photograph No. 6

Description: View of former paint and varnish tanks on third floor of Building #7 (north room).

Photo orientation: Facing northeast.

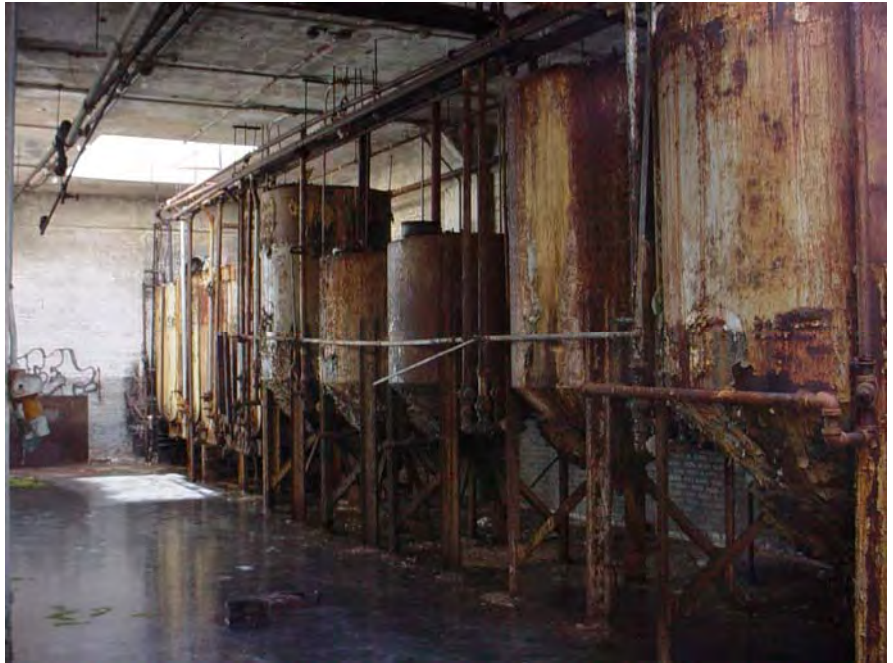
Description: View of former paint and varnish tanks on third floor of Building #7 (south room).

Photo orientation: Facing east, southeast.

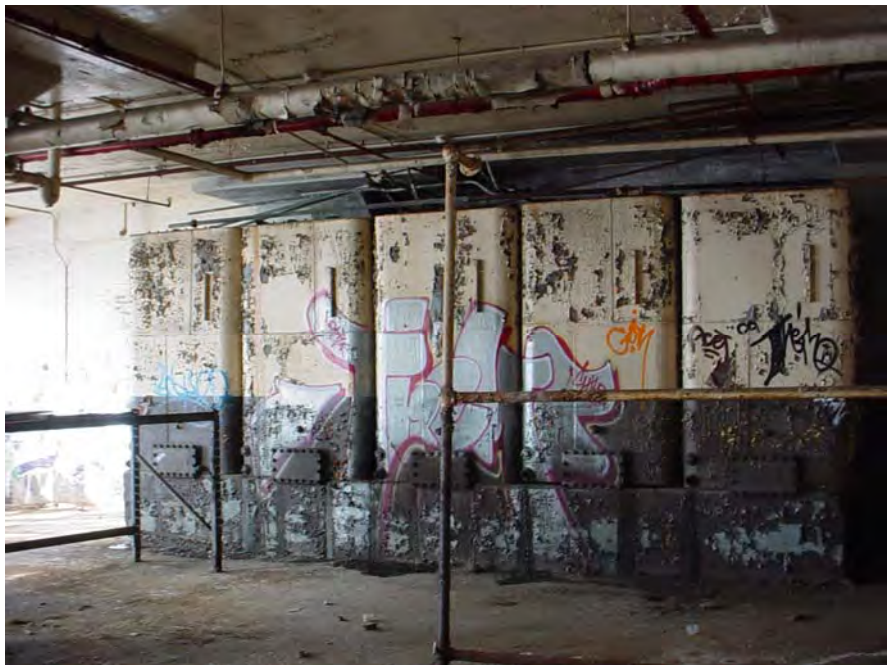
Photograph No. 8

Description: View of former paint and varnish tanks on second floor of Building #7 (south room).

Photo orientation: Facing west.

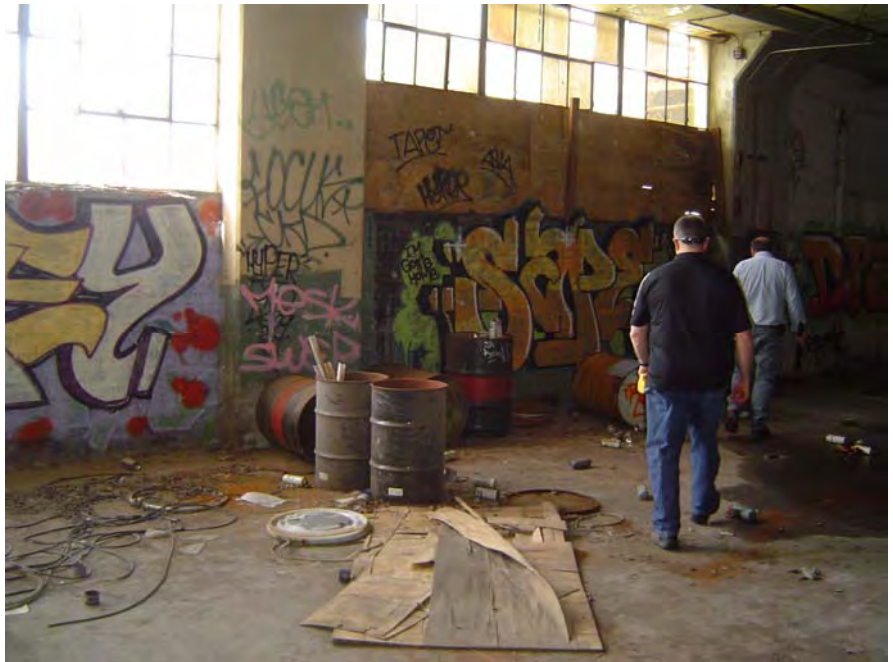
Description: View of drums on first floor of Building #12.

Photo orientation: Facing west.

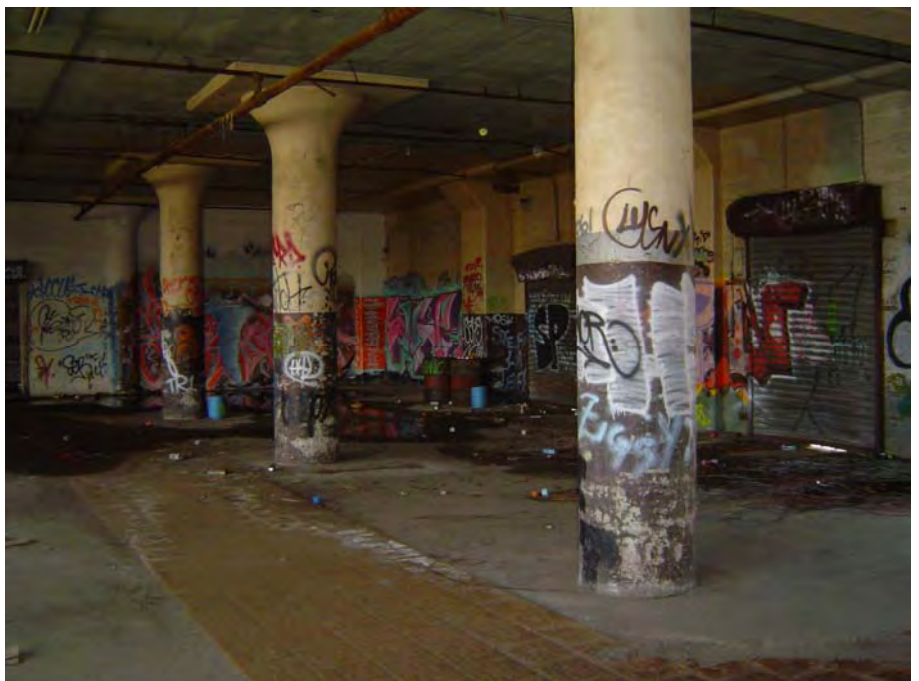
Photograph No. 10

Description: View of drums and containers on first floor of Building #12.

Photo orientation: Facing west, northwest.

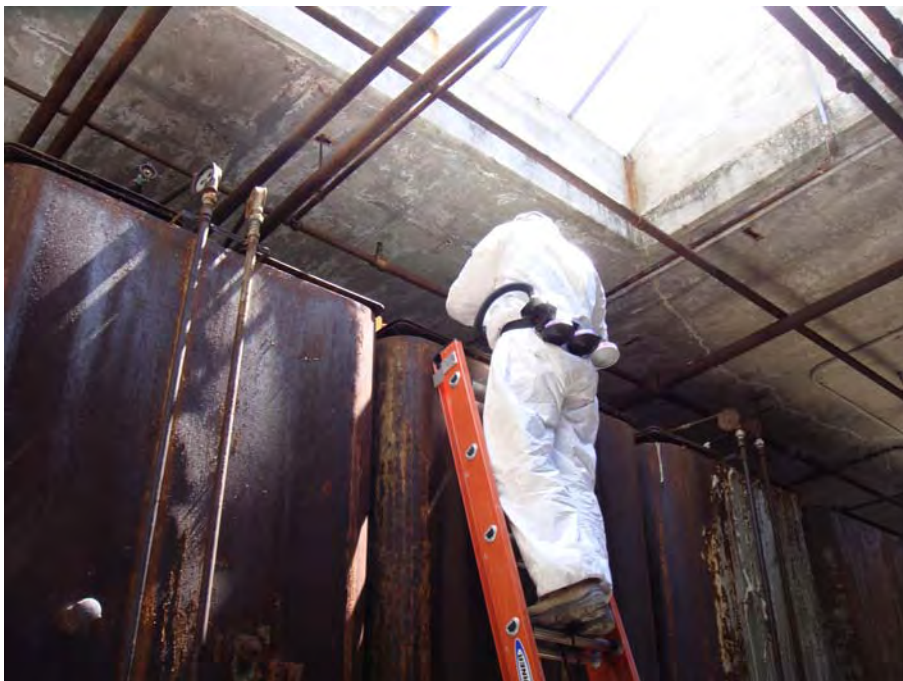
Description: View of Tetra Tech personnel inspecting paint and varnish tanks on third floor of Building #7.

Photo orientation: Facing northeast

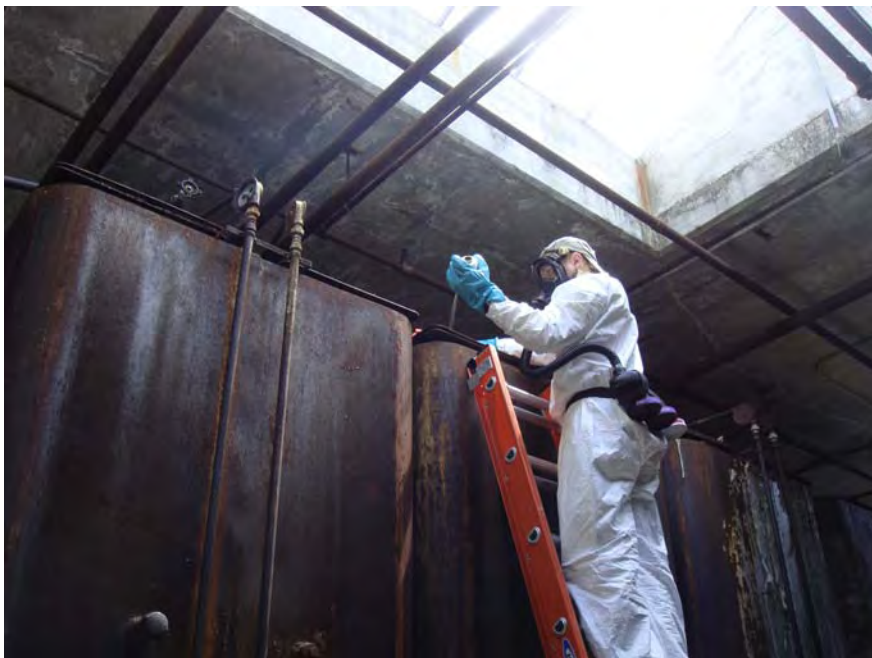
Photograph No. 12

Description: View of Tetra Tech personnel collecting sample from paint or varnish tank on third floor of Building #7.

Photo orientation: Facing northeast

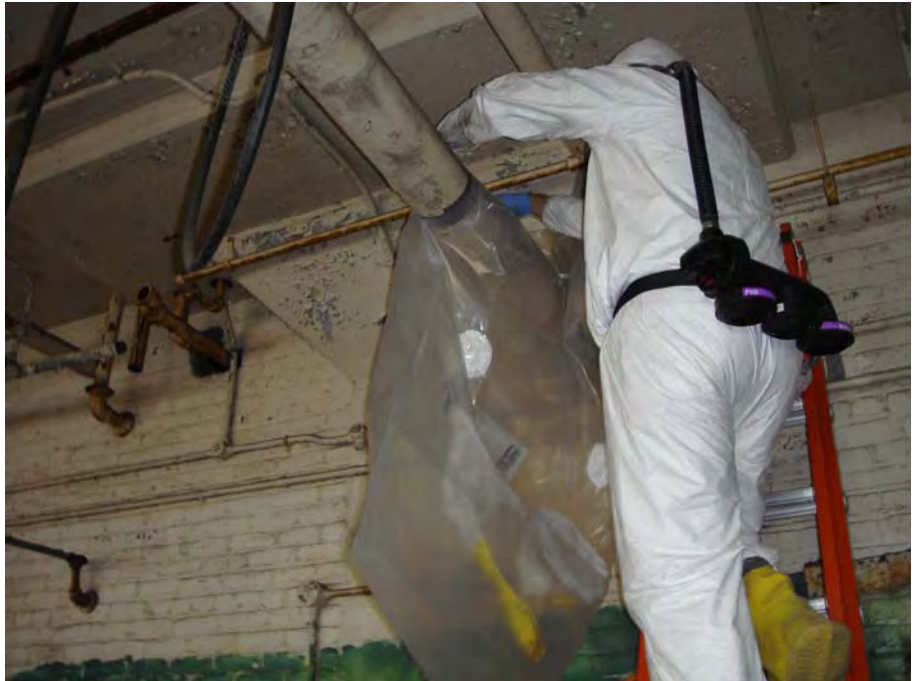
Description: View of Tetra Tech personnel using a glove bag to collect a sample of pipe insulation from a pipe on the second floor of Building #7. The insulation is thought to contain asbestos.

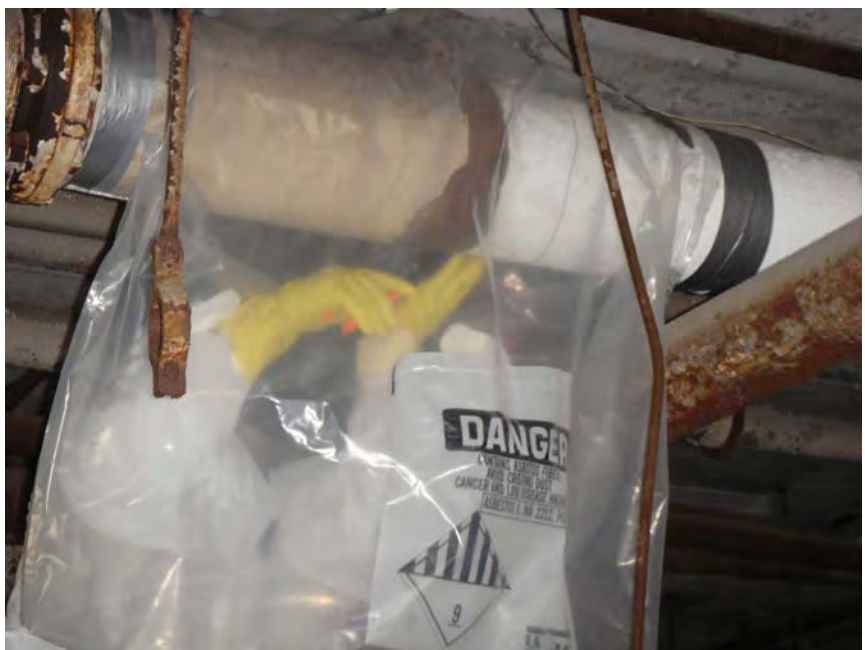
Photograph No. 14

Description: View of Tetra Tech personnel using a glove bag to collect a sample of pipe insulation from a pipe on the first floor of Building #7. The insulation is thought to contain asbestos.

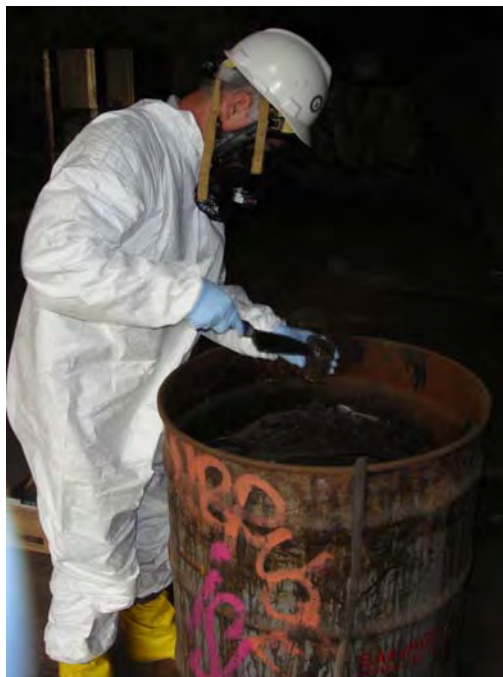
Description: View of Tetra Tech personnel collecting a sample from a drum on the first floor of Building #7.

Photo orientation: Facing east southeast.

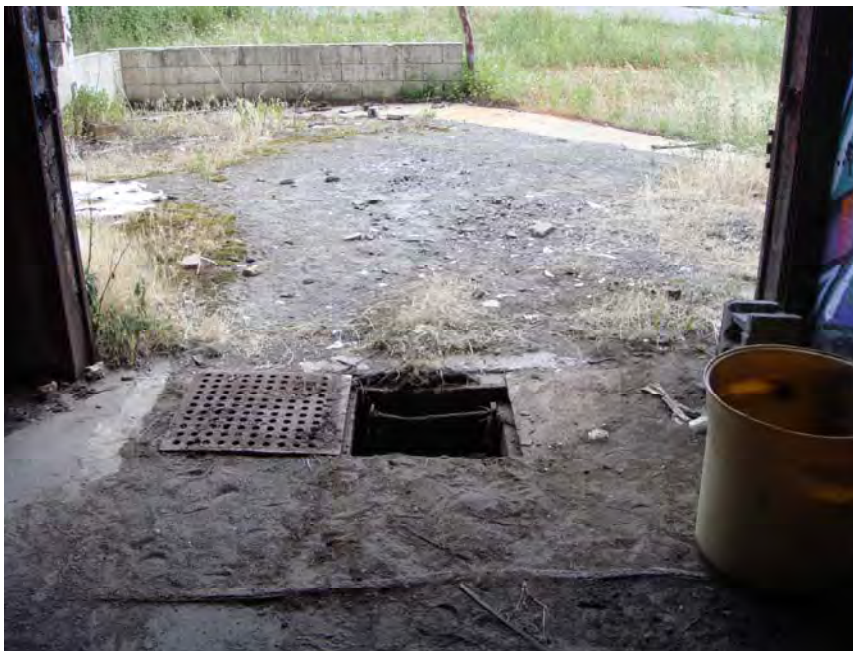
Photograph No. 16

Description: View of manhole leading into subbasement of Building #7 (garage bay, south west side). Also location of samples B7-BW-01, B7-BW-03. B7-SED-02 and BW-SED-03.

Photo orientation: Facing south southwest.

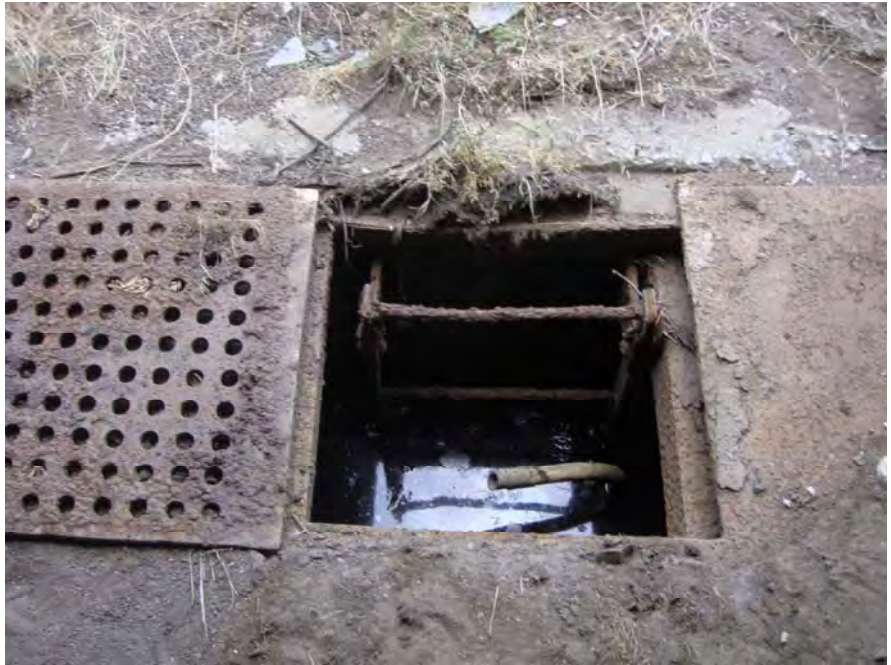
Description: View of manhole leading into subbasement of Building #7 (garage bay, south west side). Also location of samples B7-BW-01, B7-BW-03, B7-SED-02, and BW-SED-03.

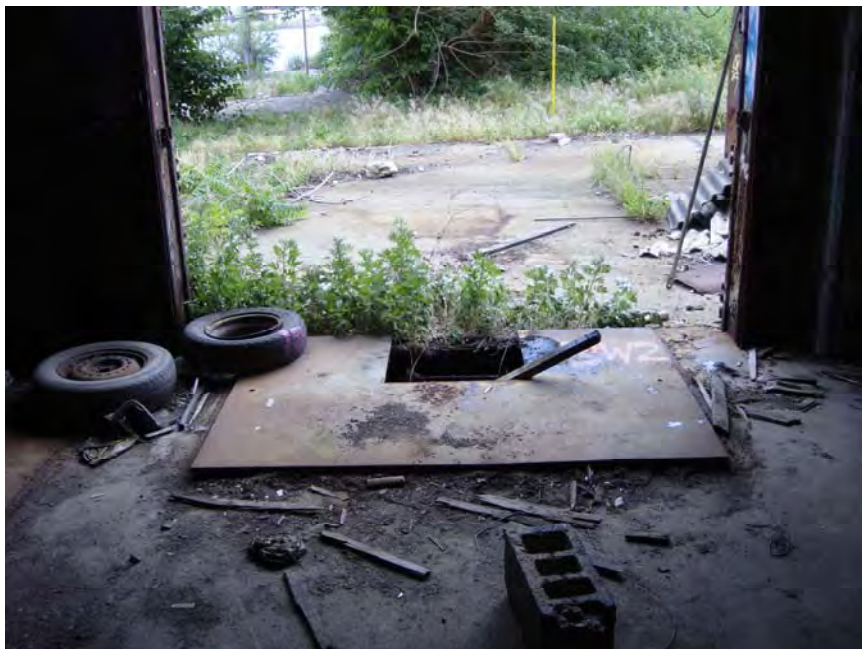
Photograph No. 18

Description: View of manhole leading into subbasement of Building #7 (garage bay, south east side). Also location of samples B7-BW-02, and BW-SED-04.

Analytical results of the sediment samples collected from the Building #7 subbasement revealed numerous VOCs with the highest concentrations detected in B7-SED-04 including 1,1,2-trichloro-1,2,2-trifluoroethane (27,000 µg/kg), acetone (11,000 µg/kg), methyl acetate (12,000 µg/kg), methylene chloride (220,000 µg/kg), 2-butanone (120,000 µg/kg), chloroform (110,000 µg/kg), 1,1,1-trichloroethane (1,100,000 µg/kg), trichloroethene (5,200 µg/kg), methylcyclohexane (2,900 µg/kg), 4-methyl-2-pentanone (24,000 µg/kg), toluene (230,000 µg/kg), tetrachloroethene (280,000µg/kg), chlorobenzene (2,200 µg/kg), ethylbenzene (58,000 µg/kg), 1,1,2-trichloroethane (91,000 µg/kg), o-xylene (240,000 µg/kg), m,p-xylene (230,000

SVOCs were also detected in Building #7 subbasement sediment samples. The highest concentrations were reported in B7-SED-04 including phenol (2,200,000 µg/kg), 2-methylphenol (4,700,000 µg/kg), acetophenone (430,000 µg/kg), 4-methylphenol (1,400,000 µg/kg), 2,4-dimethylphenol (430,000 µg/kg), 1,1-biphenyl (56,000 µg/kg), 2-chloronaphthalene (110,000 µg/kg), diethylphthalate (240,000 µg/kg), and bis(2-ethylhexyl)phthalate (230,000 µg/kg).

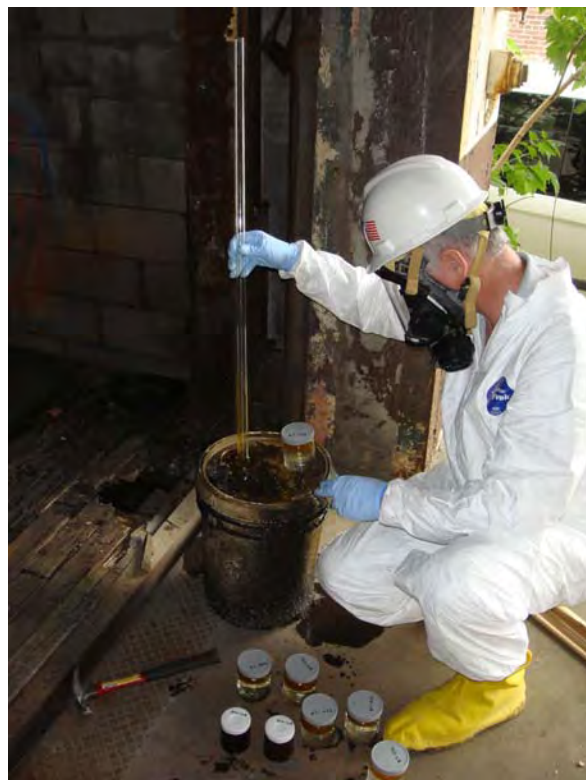
Photograph No. 20

Description: View of Tetra Tech personnel collecting a sample from a 5-gallon pail on the first floor of Building #7. (Sample B7-PS-01)
